Technical Note N-1424

INSPECTION OF OBJECTS RETRIEVED FROM THE DEEP OCEAN - AUTEC
ACOUSTIC ARRAY

February 1976

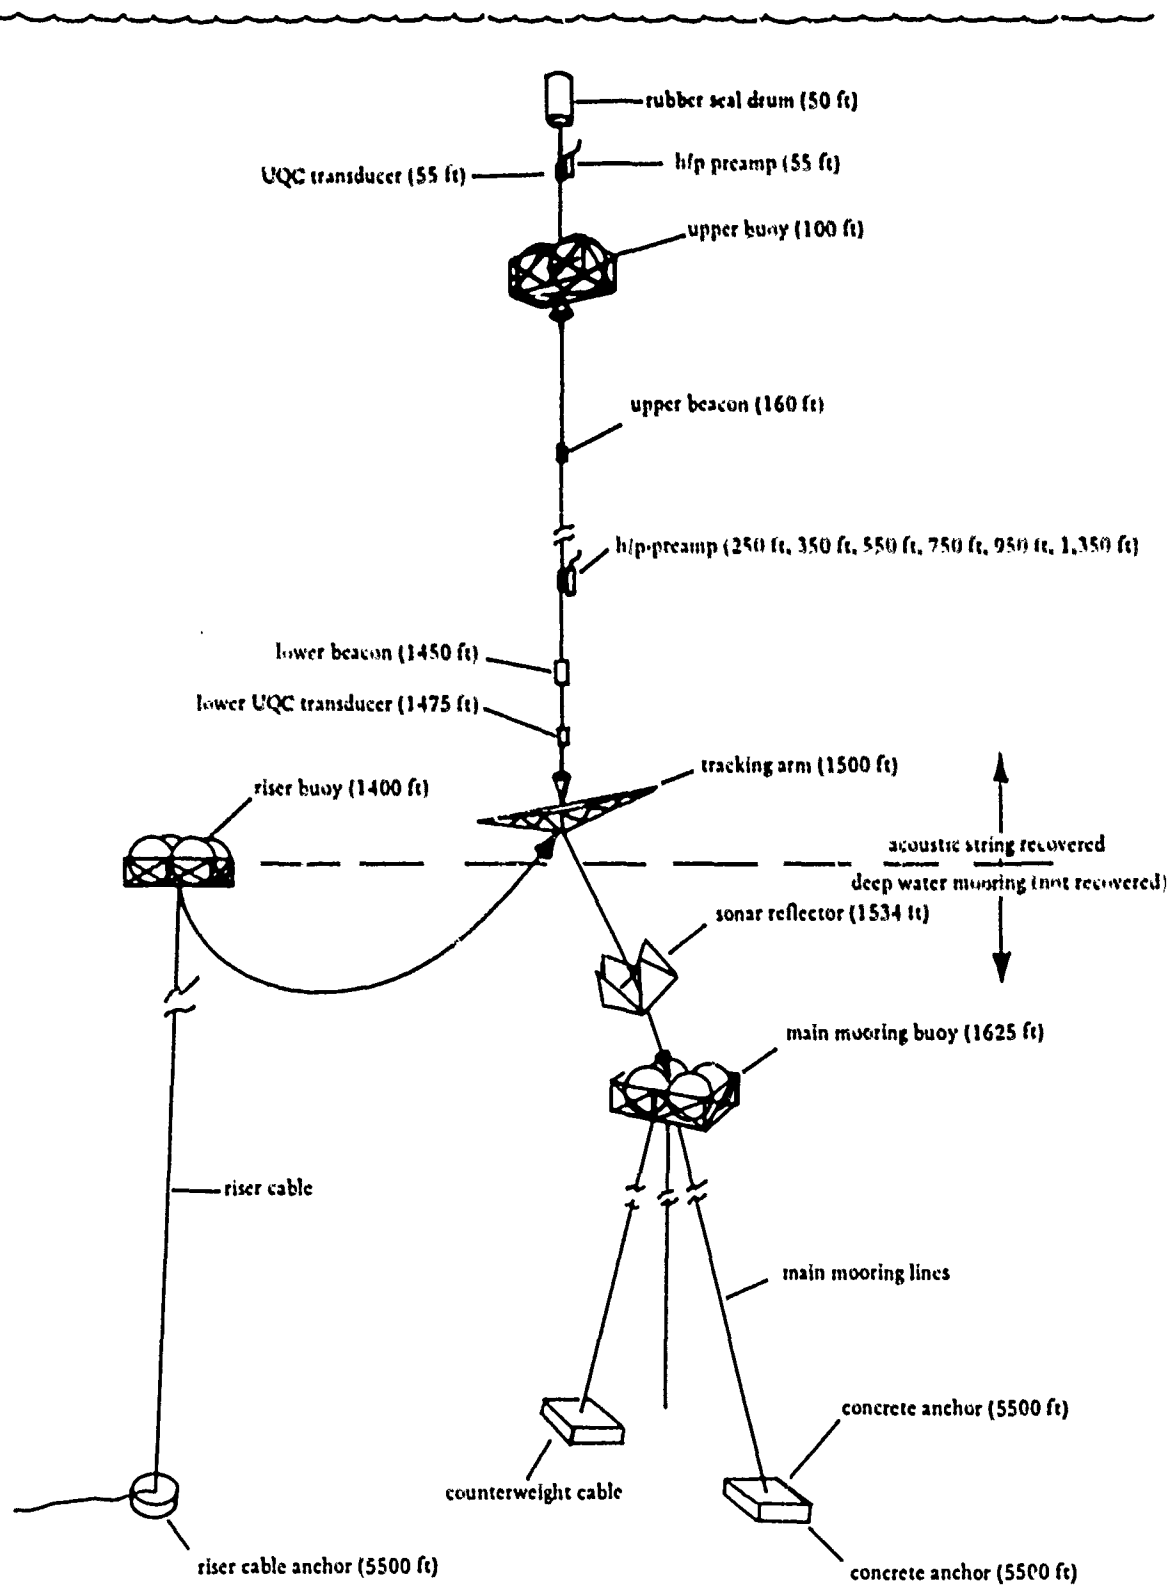
Figure 1. AUTEC acoustic array.

As shown in Figure 1, the AUTEK acoustic array emplaced in 1962, consists of two main parts: the deep water mooring and the acoustic string. The system was so designed that the acoustic string could be retrieved and replaced without retrieving the deep water mooring. In December 1973 the upper buoy was found washed ashore. The 21-quid cable used in the acoustic string had parted at or near the cable termination on the second termination below the main buoy. It was determined during an inspection of the failed array using a manned submersible that the acoustic string had fallen on the main mooring buoy. It was then planned to retrieve the acoustic string by attaching to the bitter end of the failed 21-quid cable, raising the bitter end to the surface, and then retrieving the acoustic string in a normal manner. It was planned to replace the failed acoustic string with a new unit if the condition of the deep water mooring, as inferred from the condition of the failed acoustic string, could be expected to have a reasonable additional service life.
